Manhole Inspection Summary

Manhole # S45C__070MH

Insp Date: **8/15/08 10:31 AM**

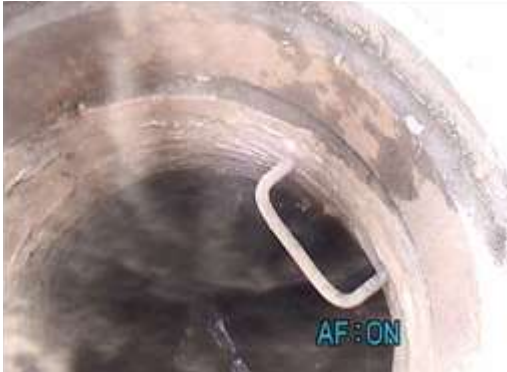
Defect 1

☒ **Leaks**

Frame leaks

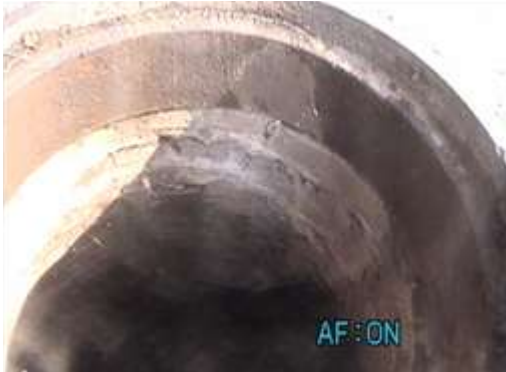
Defect 2

Infiltration: ☐ None ☐ Joint ☐ Cracks ☒ **Mortar** ☐ Roots ☐ Wall

Infiltration: ☐ None ☐ Joint ☐ Cracks ☐ Mortar ☐ Roots ☒ **Wall**

Infiltration

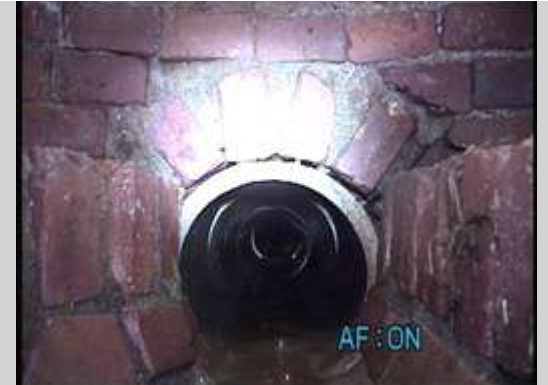
12 O'Clock Outflow

8 in. Circular Gravity Sewer
Pipe Out @ 12 O'Clock

Pipe Height: **8.4** (in.) Rod and Bar (Angled)
Pipe Material: **Clay** ☐ Pipe Lined
Invert Depth: **10.00** (ft.) Flow Characteristics: **Fast**
Deposits: ☒ None ☐ Mud ☐ Sludge ☐ Debris ☐ Grease
Silt Depth: (in.) Deposits Extent:
Infiltration: **None** Pipe Seal Cond: **Sound**

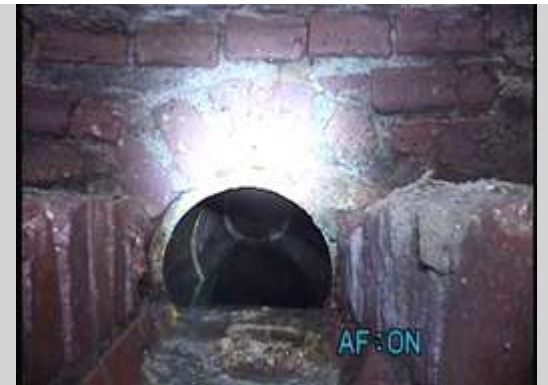
6 O'Clock Inflow

8 in. Circular Gravity Sewer
Pipe In @ 6 O'Clock

Pipe Height: **8.4** (in.) Rod and Bar (Angled)
Pipe Material: **Clay** ☐ Pipe Lined
Invert Depth: **9.85** (ft.) Flow Characteristics: **Fast**
Deposits: ☒ None ☐ Mud ☐ Sludge ☐ Debris ☐ Grease
Silt Depth: (in.) Deposits Extent:
Infiltration: **None** Pipe Seal Cond: **Sound**

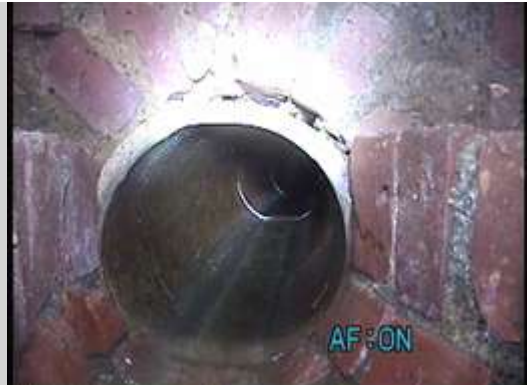
9 O'Clock Inflow

Pipe In @ 9 O'Clock

Infiltration: **None** Pipe Seal Cond: **Sound**
